RE: Farmington Fire Station – Farmington, New Hampshire
JEK Project No. Y8N00500

Farmington Fire Station Report 9-26-07

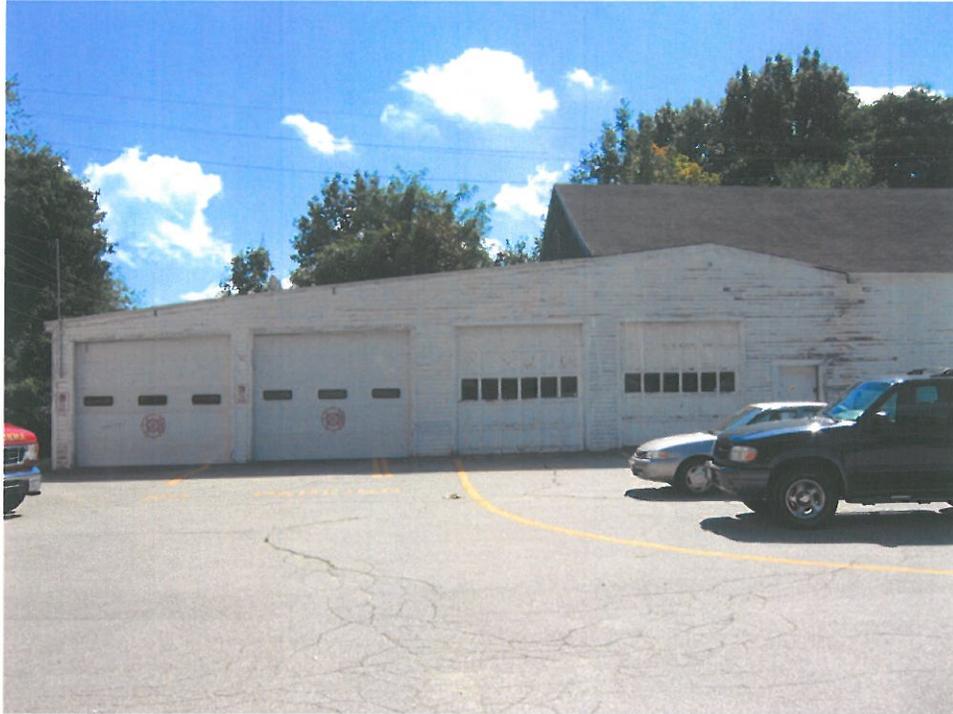
Photo 1 – Ambulance annex northwest elevation

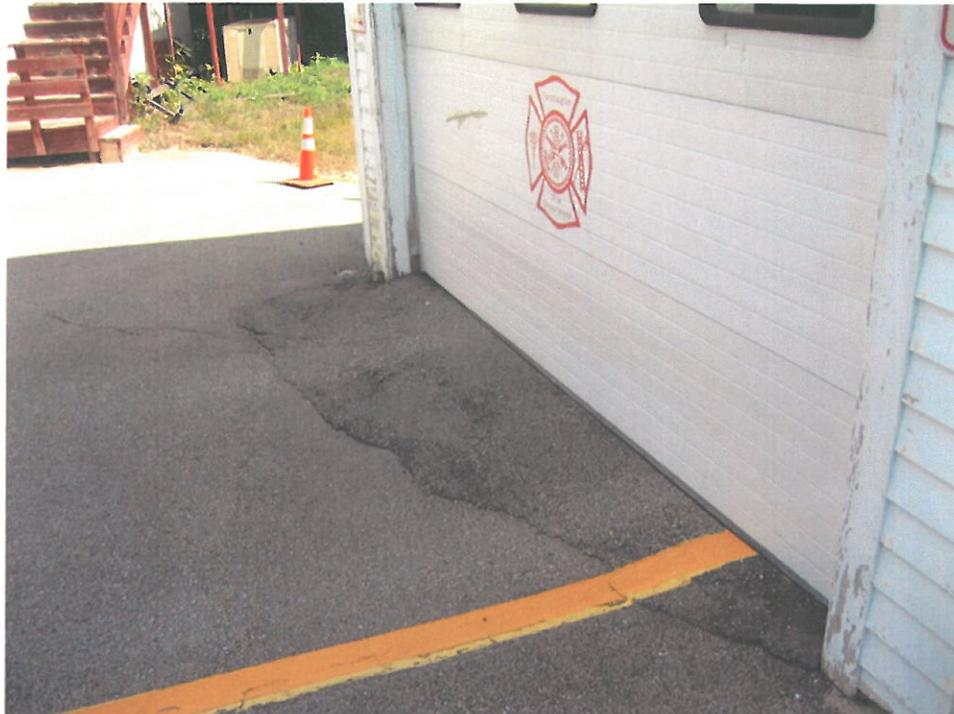
Photo 2 – Northeastern most overhead door, note the asphalt has been significantly built up to near the corner of the building.

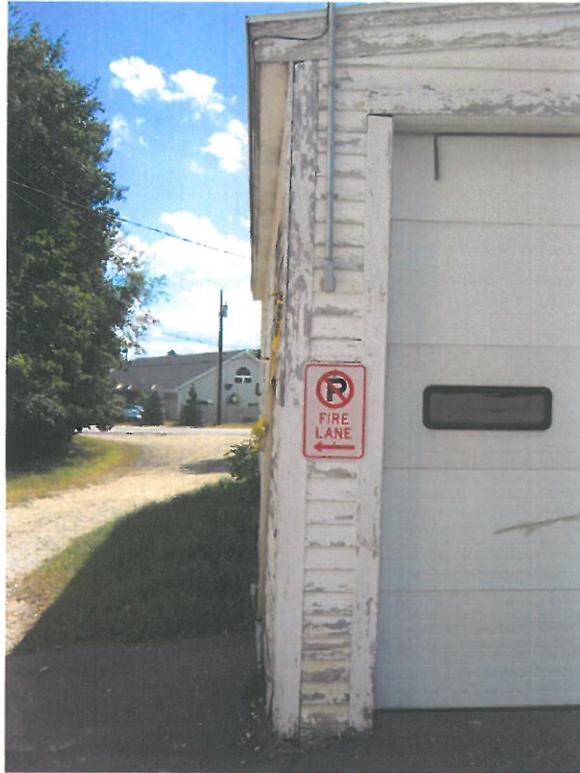
1. In photo 1 the front of the ambulance annex can be seen. In this photo the two overhead doors on the left side of the photo have been used for the ambulances and the remainder of the building is used by the water department.
2. It was observed that there was a significant amount of asphalt in front of the most northeastern door. It appeared that this asphalt was used to divert surface runoff from the north corner of the building. It also appeared that this asphalt had been in place for some time.
3. Photo 3 shows the north corner where it appears that the bottom of the wall is kicked out. A four foot level was used to check the wall on the interior and exterior and it was found that the bottom of the wall leans out approximately $\frac{3}{4}$ " in four feet. When the wall was observed from the middle to the east corner it was found to be plumb.

Photo 3 – Northern corner looking along northeastern side. Note the bottom of the wall is pushed out.

Another area of concern is the northeast wall of the ambulance annex. The northern end of this wall is significantly out of plumb and, based on our observations, has been for some time. It appears from our limited observations that the wall is currently stable, however, if there is a significant snow load placed on the roof it is our opinion that there would be a concern with its stability. Also, if the roof rafters are 2x8's spanning 14 feet as it appears, it is our opinion, that they would be undersized for the current design snow load. Therefore, we recommend that the roof be shoveled immediately following a snow event. An alternative to shoveling the roof would be to construct a temporary wall no more than 10 feet from the beam and 4 feet off the northeast wall. This wall would have to directly support the roof rafters, not the ceiling joists, and it could bear on the existing concrete floor slab. It is further recommended that a more detailed analysis be conducted on this building to determine if the roof structure meets the current building code requirements for snow loading.

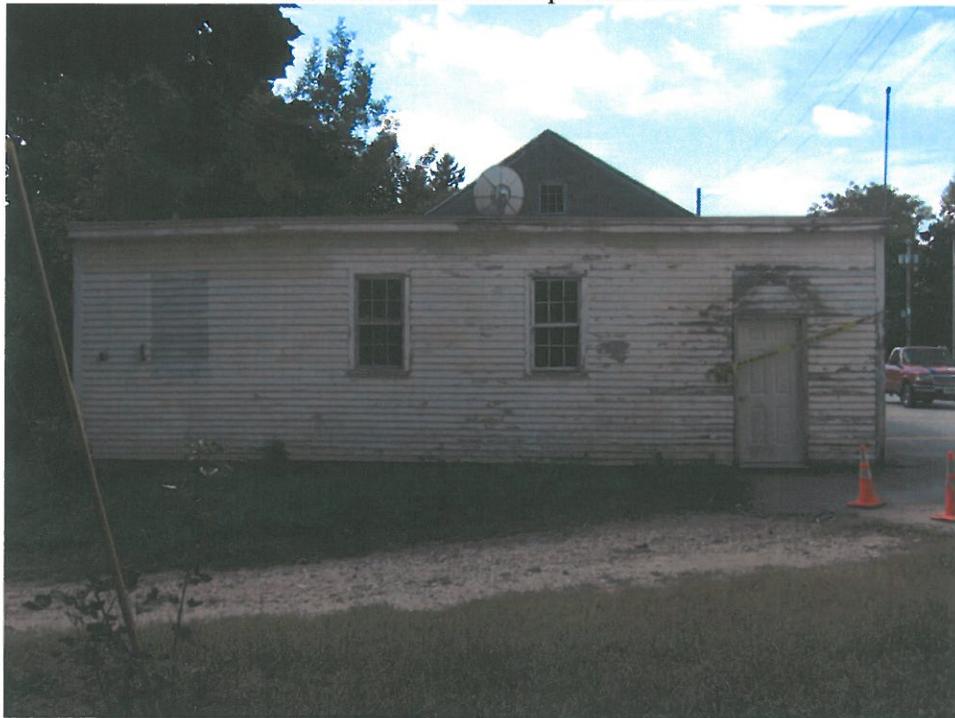
4. The northeast wall can be seen in photo 4. In this photo it can be seen that the roof appears to have a high point to the left of the window in the middle of the wall. It can also be seen that there is an outline of where the awning roof was located over the door.

Photo 4 – Northeastern wall of ambulance annex. Note the outline of a roof over the door.

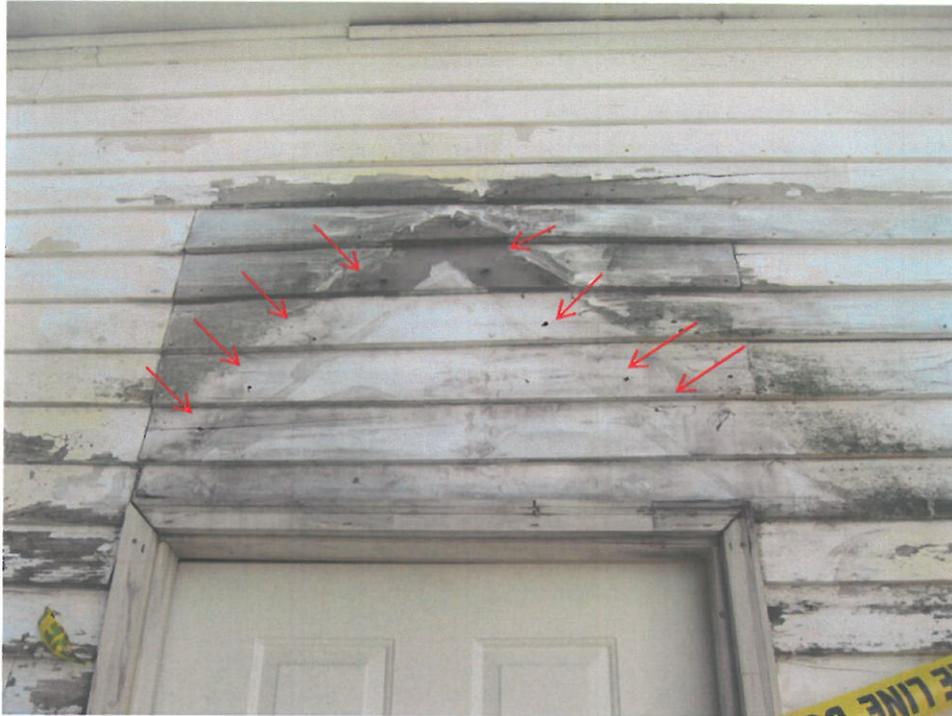
5. Photo 5 is a close up of the area above the door where it is noted that there are nail holes in the siding. It appears that the awning roof was only supported by these nails. It is also clear that the awning was constructed after the siding was installed.

Photo 5 – Close up view of roof outline over door. Note the nail holes where the framing was nailed to the wall.

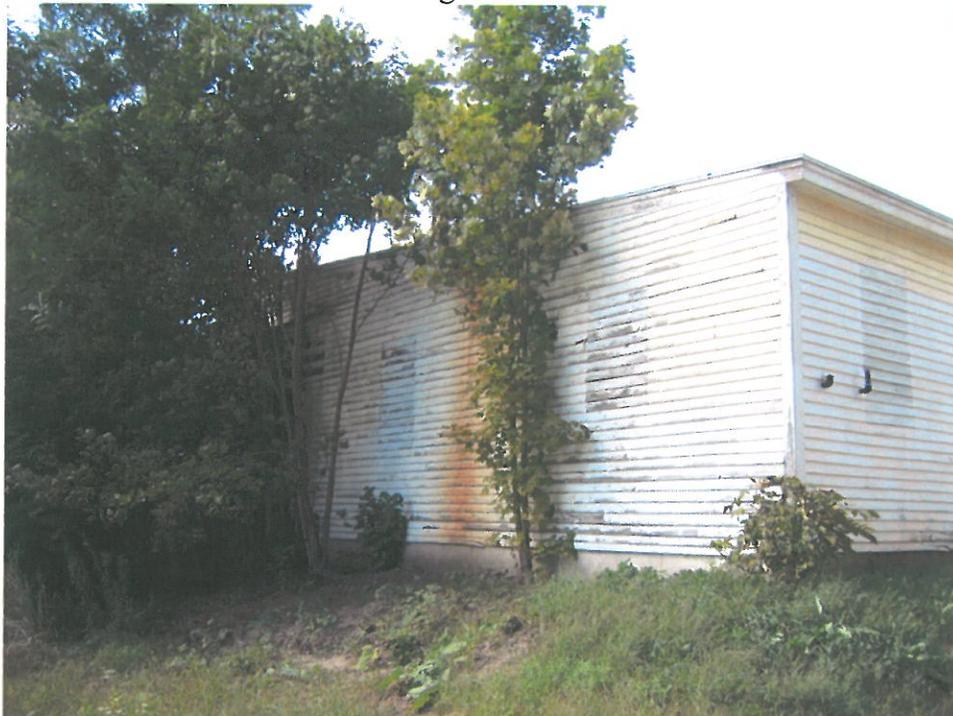
6. The southeast, rear, of the building can be seen in photo 6. It was noted that there was no visible damage to the foundation or the wall. There was a rust stain on the siding which we believe is the result of water running off the roof in this area.

Photo 6 – Southeast side of ambulance annex, note there is no visible damage to the foundation or this wall. Also note the rust stain on the wall.

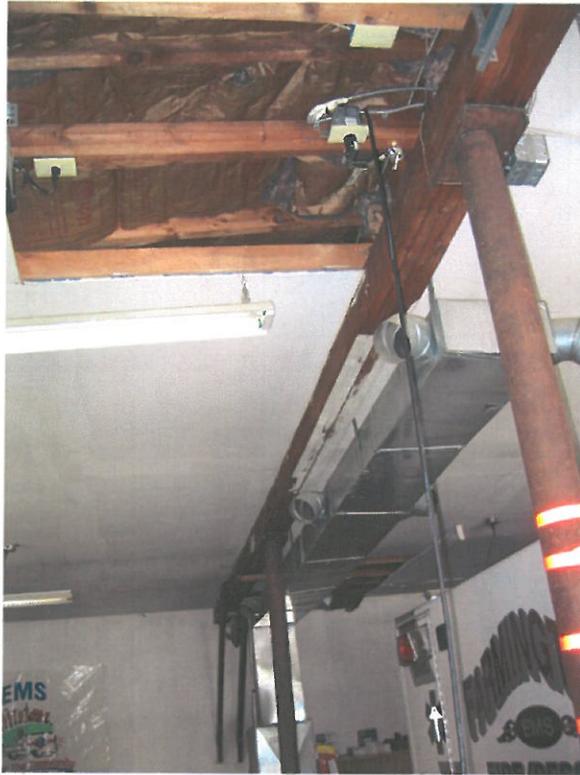
7. On the interior of the building there is a beam consisting of four pieces of dimensional lumber that were nailed together. This beam is located approximately 14 feet off the northeast wall. This is approximately the middle of the space. This beam is supported by steel columns that are approximately 12'-6" apart. This beam and support columns can be seen in photo 7.

Photo 7 – Inside ambulance annex, note the built up beam and the rafter splices. This beam is between the two overhead doors at the northeastern end of the building.

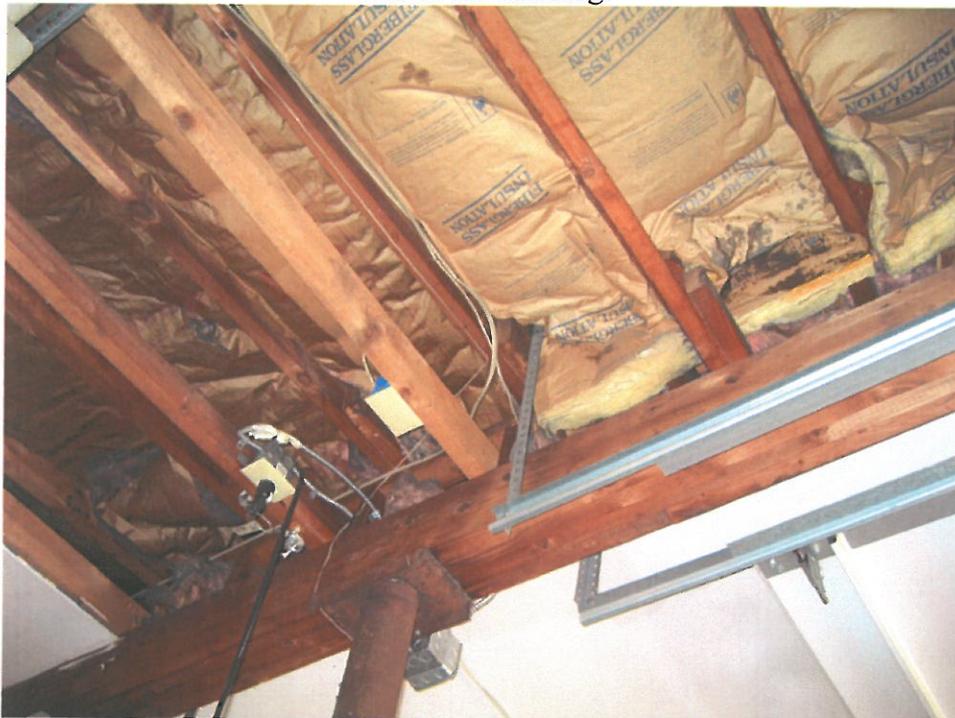
8. In photo 8 there is a close up view of one of the support columns and the beam. It was noted that the top plate of the beam is not secured to the beam and that the roof joists appear to be 2x8's. It also appears that the spacing of the rafters is 16 inches on center.

Photo 8 – Closer view of column beam connection and rafters. Note the top plate of the column does not appear to be secured to the beam.

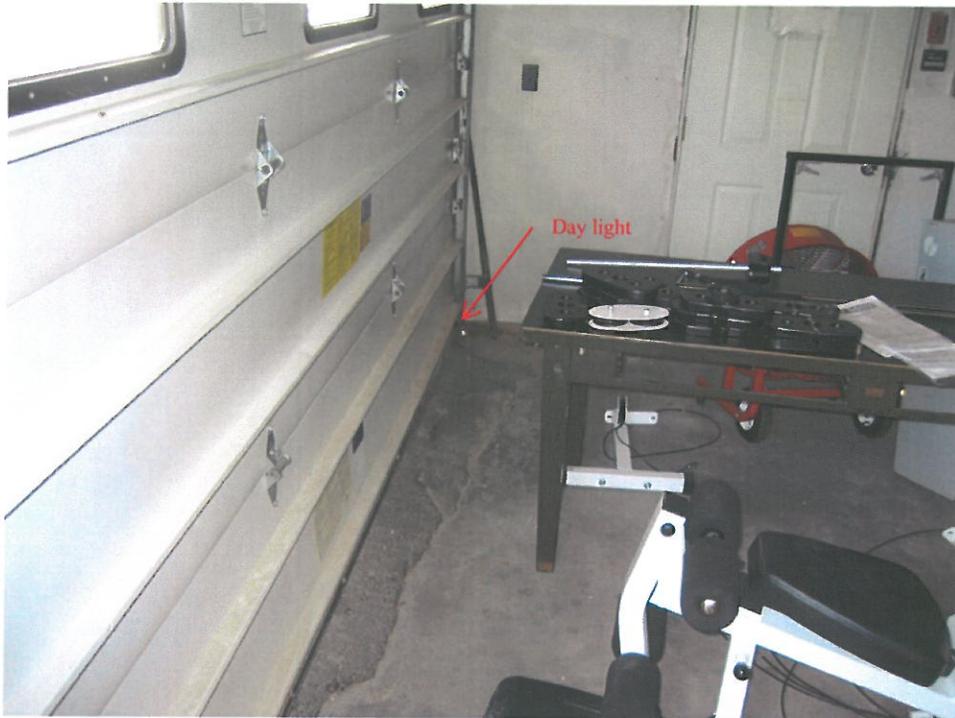
9. It was noted that there was daylight visible in the north corner at the floor. It appears that the sill had been rotted away because the water in this area drained into the corner. It can be seen in photo 9 that the asphalt berm, noted in photo 2, will not allow water to drain under the overhead door. In photo 10 it can be seen along the northeast wall that there are water stains and that the sill under the door has been built up. Also in photo 10 it appears that the sill plate of the wall has been replaced at some point.

Photo 9 – North corner, note the built up asphalt under the overhead door and that daylight can be seen in the corner.

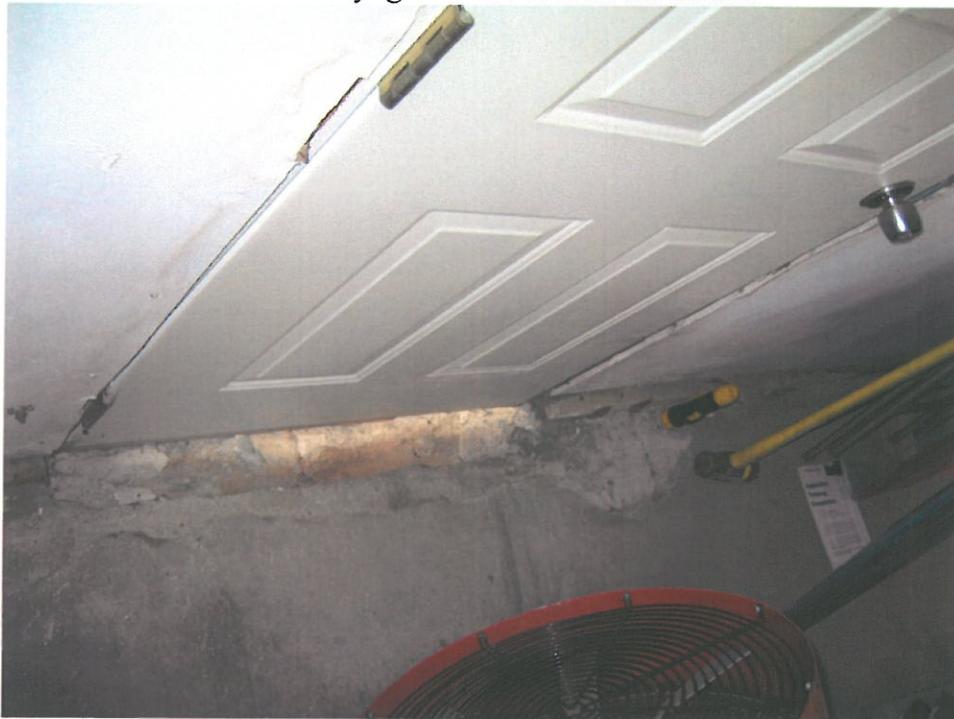
Photo 10 – Sill of door on northeastern elevation. Note the concrete is built up and the water stains. Also note, the sill of the wall appears to have been replaced and is not treated lumber.

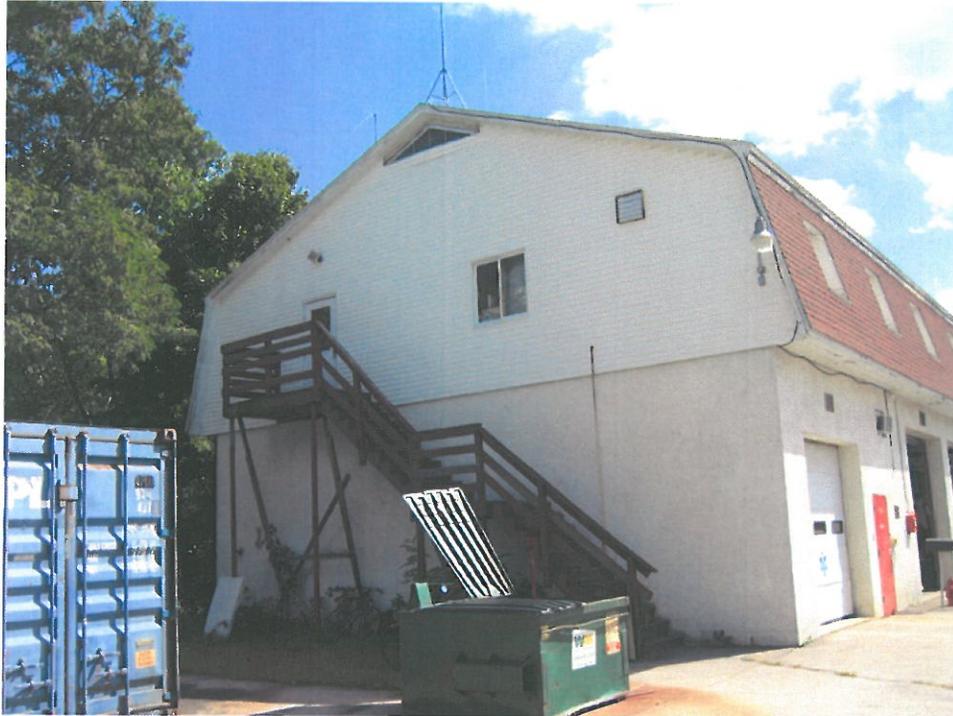
1. The northwest end on the fire station can be seen in photo 11. It was noted that the first floor of the building is a single wythe concrete masonry wall with a stucco finish. The second floor is a wood framed gambrel roof. There was no observed or reported cracks or damage in this wall.

Photo 11 – Northwest elevation of fire station. Note the first story is masonry and the gambrel section is wood framed.

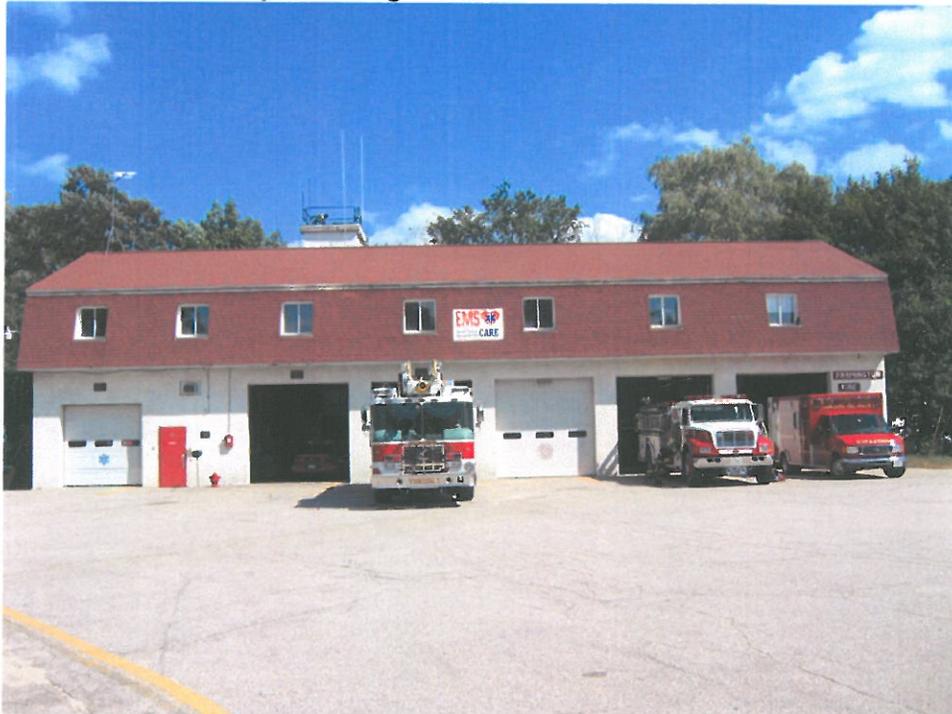
2. Photo 12 shows the southwest, front, side of the building. In this elevation there are six overhead doors and one man door. There was no observed damage or crack on this elevation with the exception of the step crack at the south corner.

Photo 12 – Southwest elevation of fire station. Note there are no visible or reported cracks in the masonry except at the south corner.

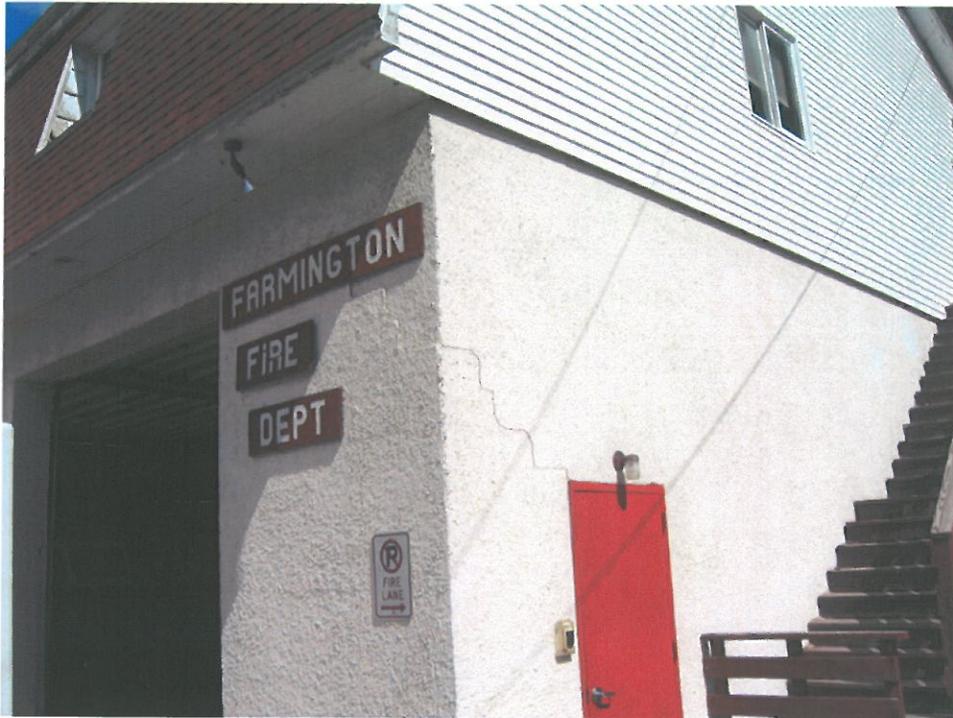
3. The step crack can be seen in photos 13, 14 and 15. This crack starts at the corner of the man door in the southeast wall and extends around the corner up to the bottom of the bond beam on the southwest wall. It can be seen in photo 14 that the block below the crack on the southwest wall is out slightly. It appears that this displacement is approximately 3/8 to 1/2 inch. In photo 15 it can be seen that the crack is approximately 1/4" wide at the corner of the door and that the sealant between the door frame and the masonry is not broken.

Photo 13 – South corner, note the step crack starting at the top of the man door on the southeast side of the building and extending around the corner to the bottom of the bond beam on the southwest side.

The step crack in the masonry at the south corner of the fire station is of some concern. It appears that this crack has existed for some time and that there may have been some movement over the past few years. At the time of our observations, it did not appear that the lower portion of the wall was significantly out of plumb. It is clear that there is some displacement of the crack on the southwest side and this is allowing water into the masonry. We would therefore recommend that this crack be sealed on the exterior and that further analysis be done to determine a long term repair. It should be noted that the

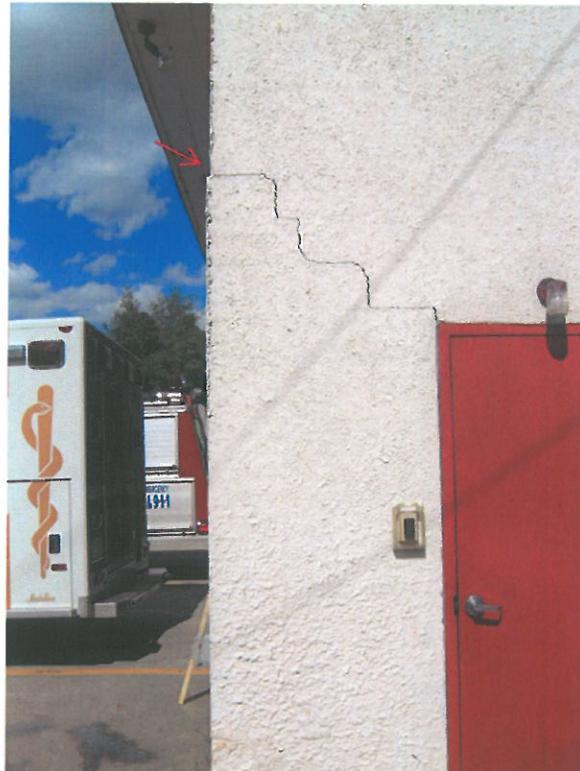
Photo 14 – view of step crack on southeast side. Note that there is displacement of the wall on the southwest side.

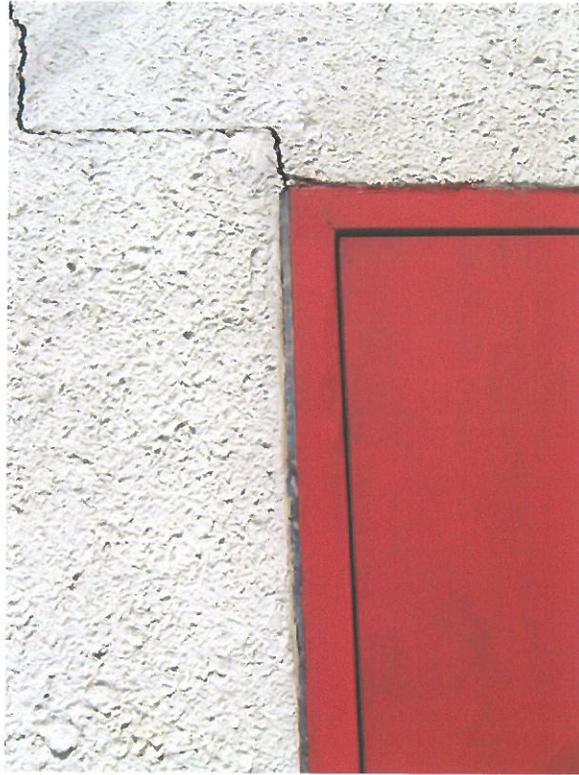
Photo 15 – Close up view of crack at corner of man door. Note the width of the crack is approximately $\frac{1}{4}$ inch wide and that the sealant between the door jam and the masonry is not broken.

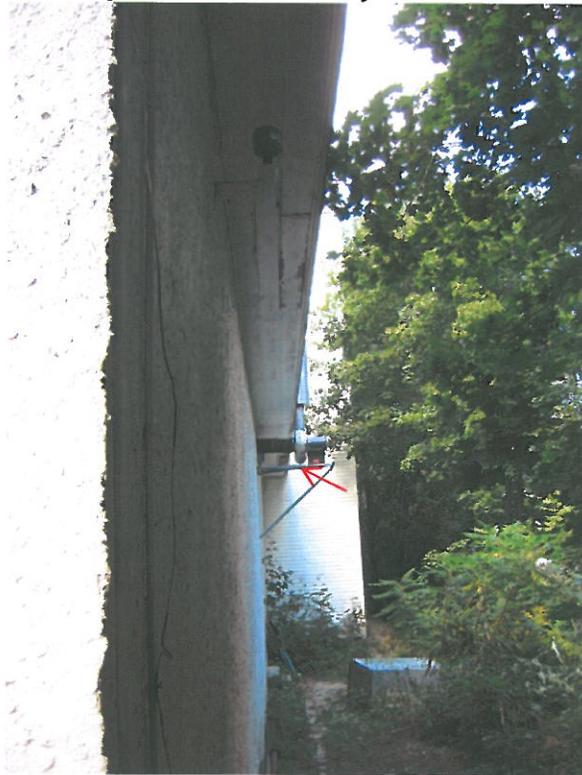
4. Photos 16 and 17 were taken along the northeast wall where it was noted that the wood soffit had been repaired, at one location, by placing a board on it. It is our understanding that this was done to keep the squirrels out of the building. It was also noted that there are control joints in the wall. The first of these is located approximately 20'5" from the exterior east corner of the building. The next joint is located approximately 21 feet from the first and the third is approximately 21 feet from the second. These control joints extend from the top of the foundation to the underside of the bond beam. It can be seen in photo 17 that the masonry wall is slightly inside the edge of the foundation wall.

Photo 16 – Northeast wall, note the repair to the wood soffit.

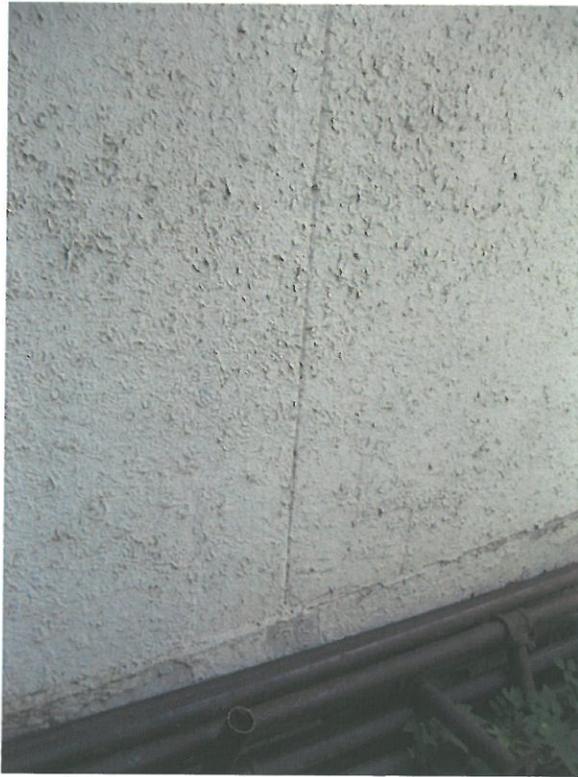
Photo 17 – Control joint on northeast wall approximately 20.5 feet from the east corner. Note the wall is slightly in from the foundation at the left side of the photo.

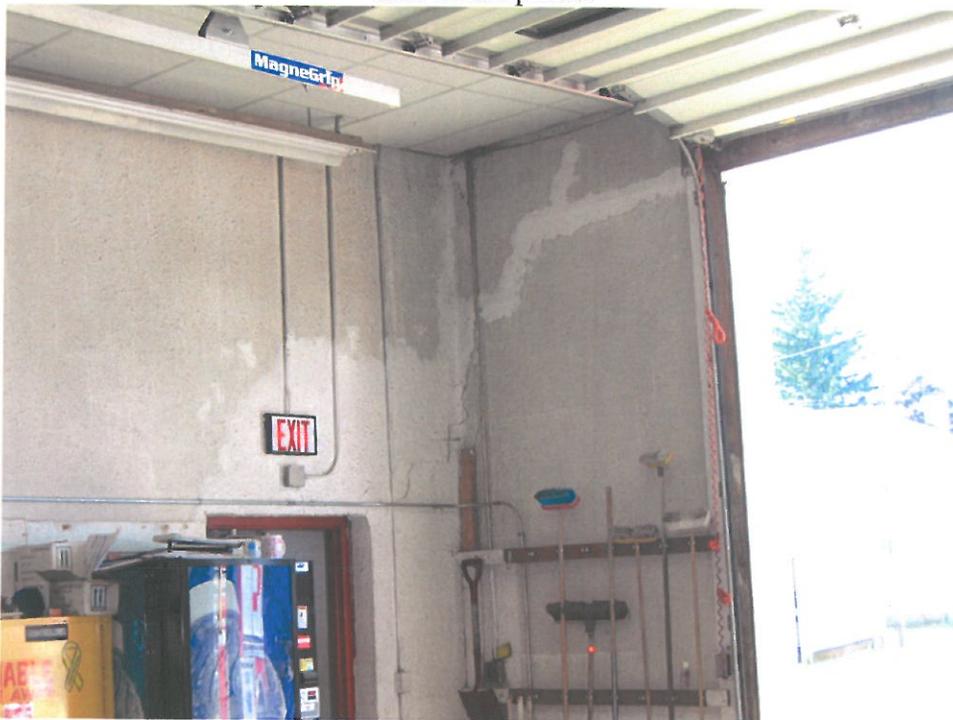
5. The interior of the south corner can be seen in photo 18. It can be seen in the photo that the stucco has been repaired in the area of the crack and that the patch has cracked.

Photo 18 - Inside the fire station at south corner, note the repair to the wall and the step crack in the repair. This is the same crack that is in photo 13.

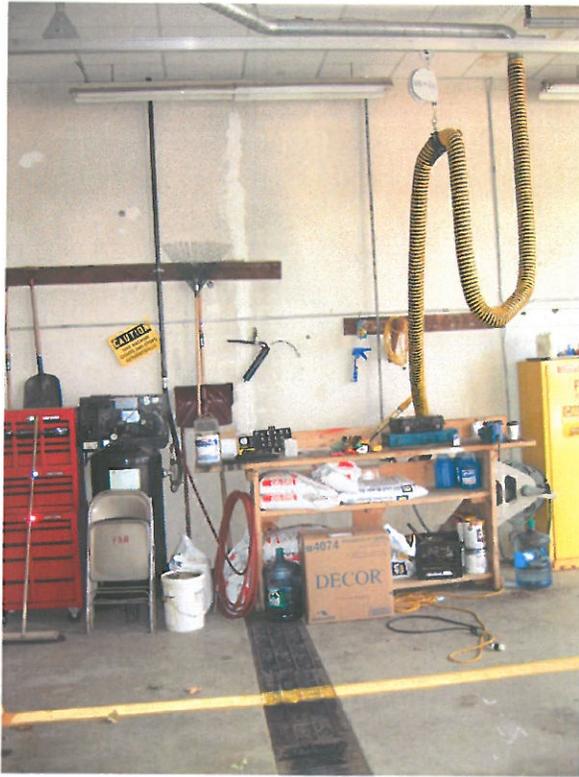
6. There is a similar patch on the southeast wall near the middle of the wall. This patch appears to be over a control joint. Please refer to photo 19.

Photo 19 – Southeast wall near the middle of wall, note the patch which appears to be at a vertical control joint.

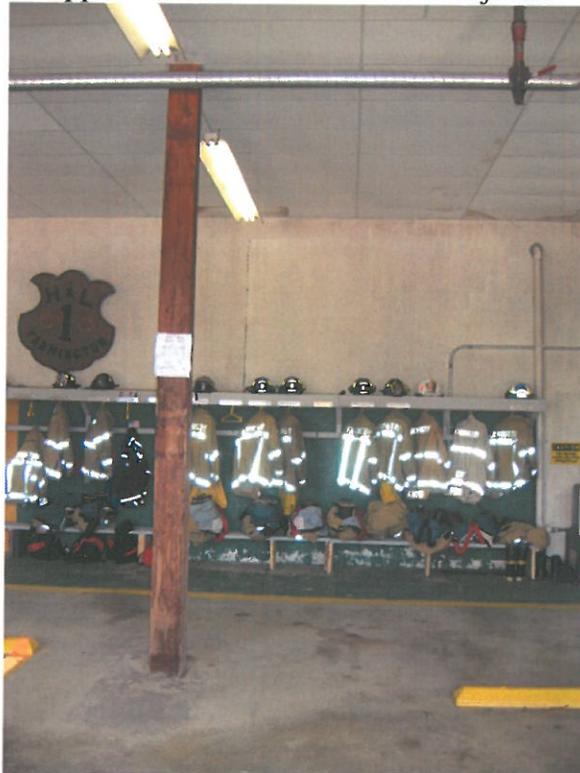
Photo 20 – Northeast wall approximately 19 feet from east corner. Note this is the same control joint shown in photo 17.

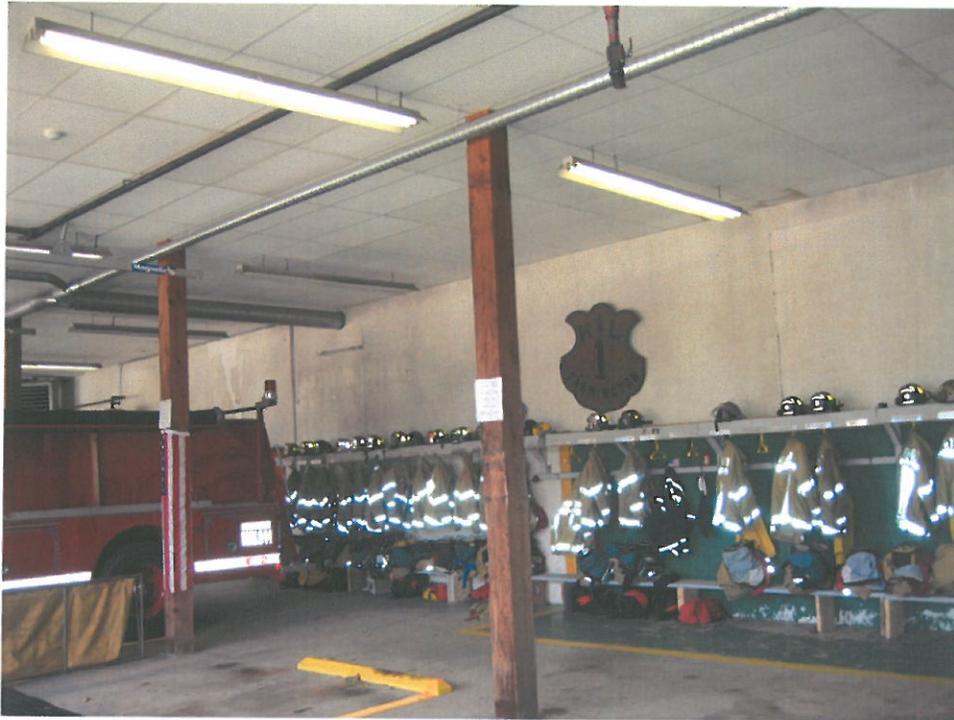
7. Photos 20 and 21 show the interior of the northeast wall. In these photos it was noted that the control joints are clearly visible. In photo 21 it can also be seen that there is a patch over the man door.

Photo 21 – Northeast wall, note control joints are approximately 21 feet apart. Also note the patch over the man door at the left of the photo.

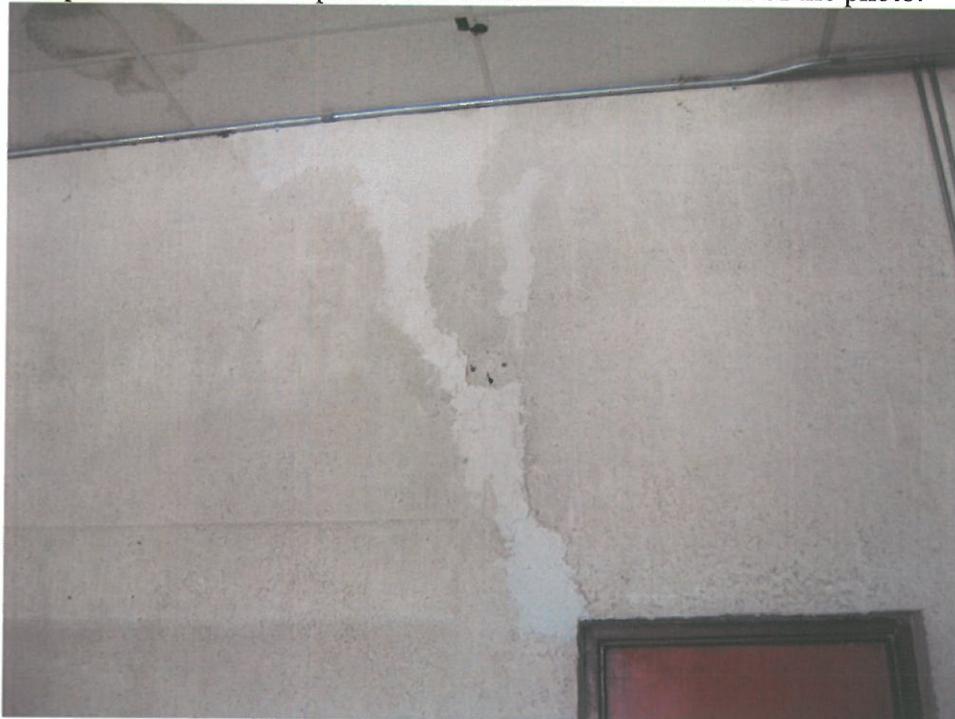
Photo 22 – Closer view of patch over man door in northeast wall.

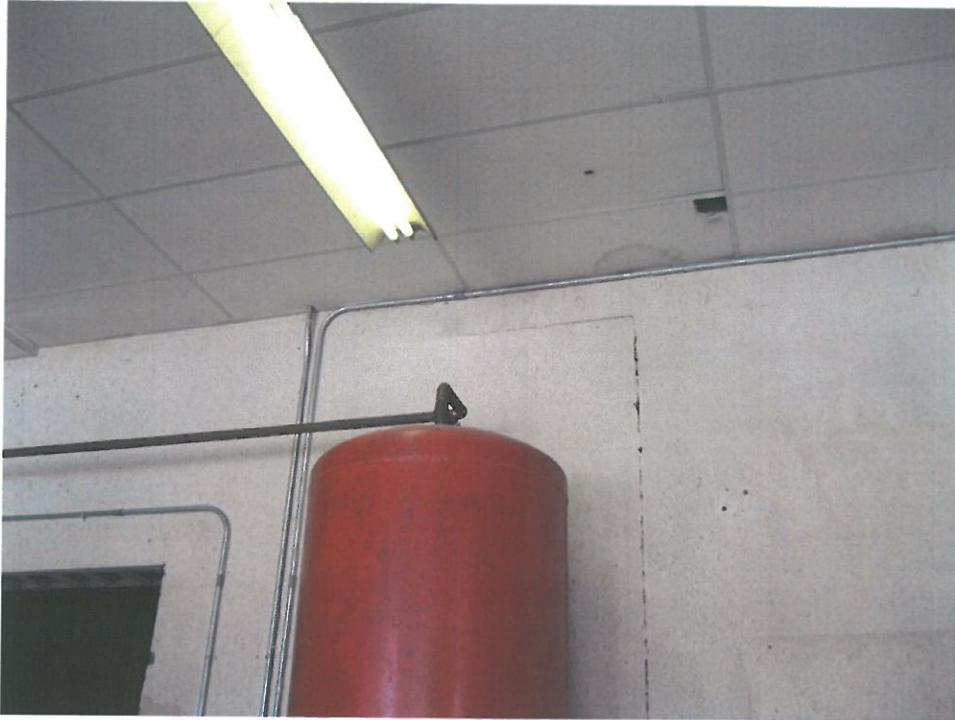
8. The patch over the man door in the northeast wall can be seen in photo 22. It did not appear that there were any new cracks in this patch.
9. The fourth control joint in the northeast wall can be seen in photo 23. In the photo there is a horizontal crack at the top of the control joint that runs a couple of feet along the mortar joint at the base of the bond beam. On the left side of the photo is the opening to the hose tower. In the photo it can be seen that the blocks in the top of this opening are open and there is no lintel supporting them.

Photo 23 – Vertical control joint to the northwest of photo 22. Note the crack goes to horizontal at the bond beam. Also note the exposed block in the opening to the left of the photo.

In conclusion, based on our observation and the assumed construction of the buildings, it is our professional opinion that there is no immediate risk of structural failure. However, there is one location that, in our opinion, does possess a life safety concern. That location is the opening to the hose tower. As it currently is constructed there is no support for the three courses of 12 inch blocks above the opening. It is our opinion, that at any time one or more of these blocks could fall. Therefore it is our recommendation that this opening be immediately shored. This shoring may be constructed of wood or steel, however, it will be necessary to anchor the shoring to the masonry. If you would like to have us design this shoring we would be pleased to provide you with a written proposal.

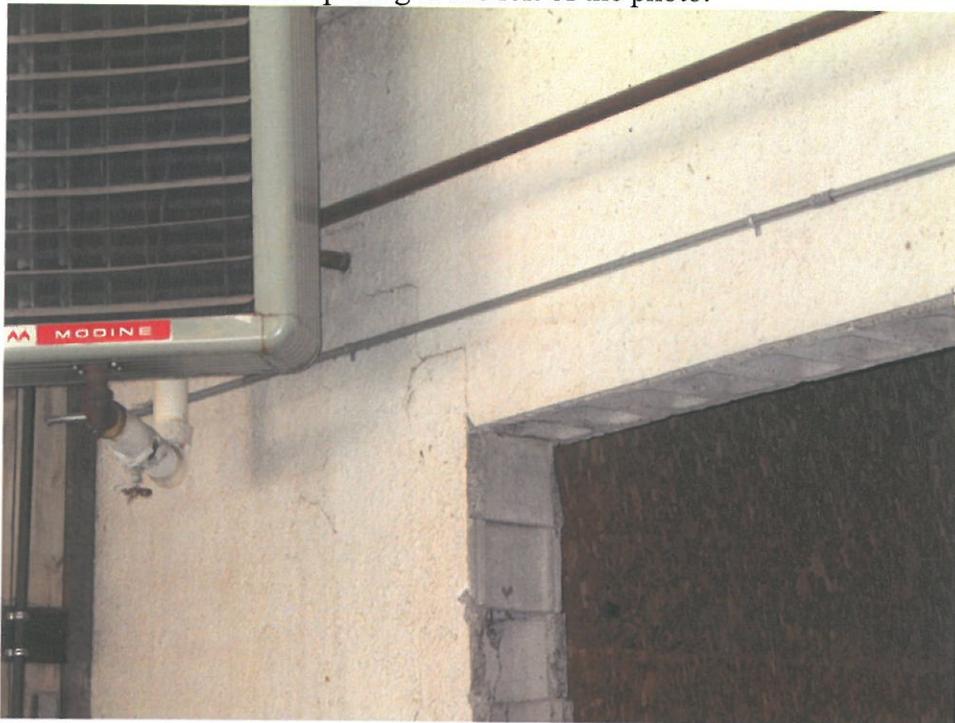
10. Photo 24 was taken on the north side of the opening to the hose tower. At this location it can be seen that there is a step crack and that two of the blocks in the opening appear to have been broken off.

Photo 24 – Step crack at the northwest side of the opening in photo 23. Note the blocks have been broken on the vertical.

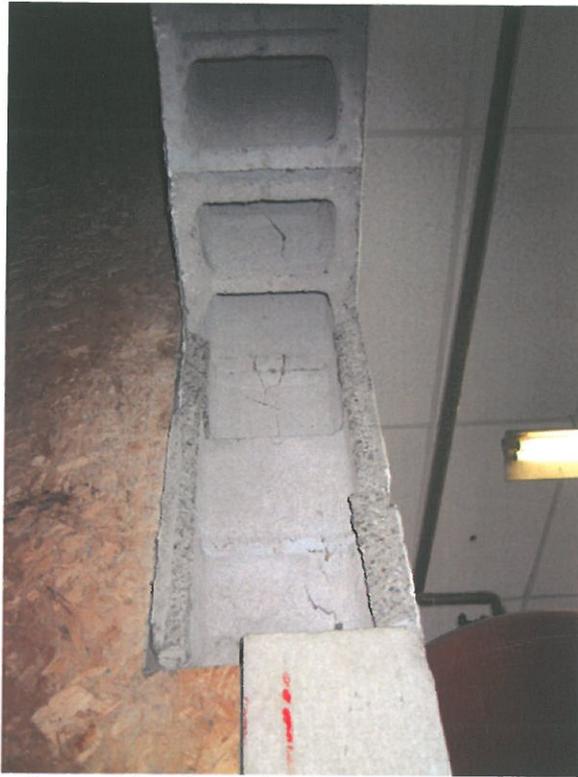
11. Photo 25 was taken on the south side of the opening where, again, it appears that three courses of blocks have been removed from the top of the opening. It was also noted that the lower portion of the wall is an 8 inch thick block and the upper portion is a 12 inch thick block.

Photo 25 – Southeast side of opening in photos 23 and 24. Note the wall thickness appears to change from 8 inch to 12 inch and that three courses of 12 inch blocks appear to have been removed.

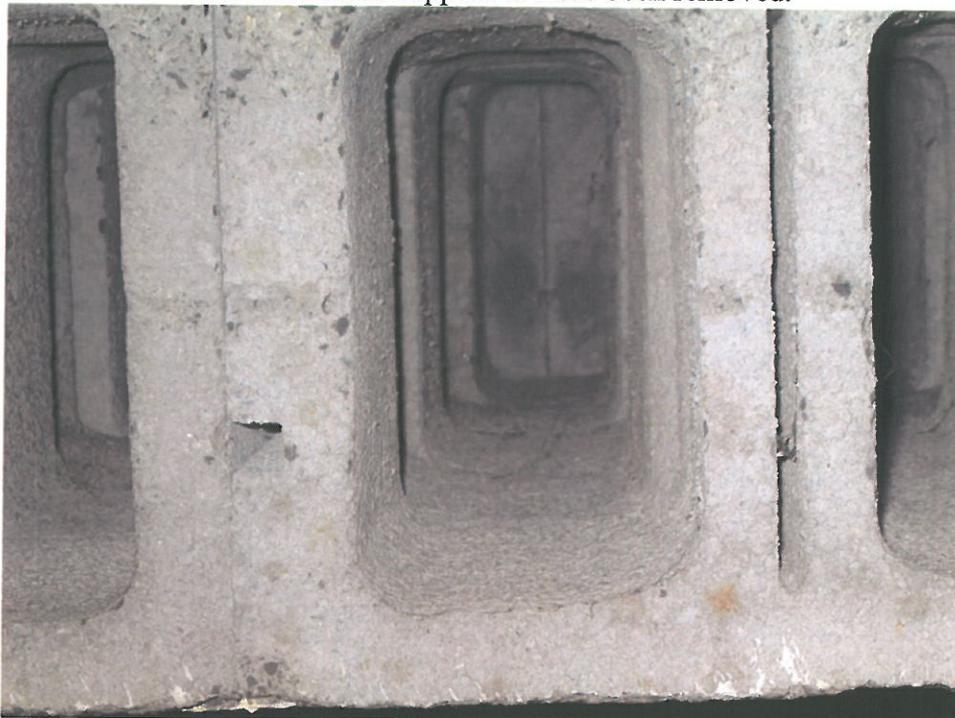
12. Photo 26 was taken looking up into the cells of the blocks in the opening. It was noted that none of the cells are grouted and there appears to be a bond beam three courses above the opening.

Photo 26 – View up through cells in opening. Note that none of the cells are grouted and there appears to be a bond beam up 3 courses above opening.

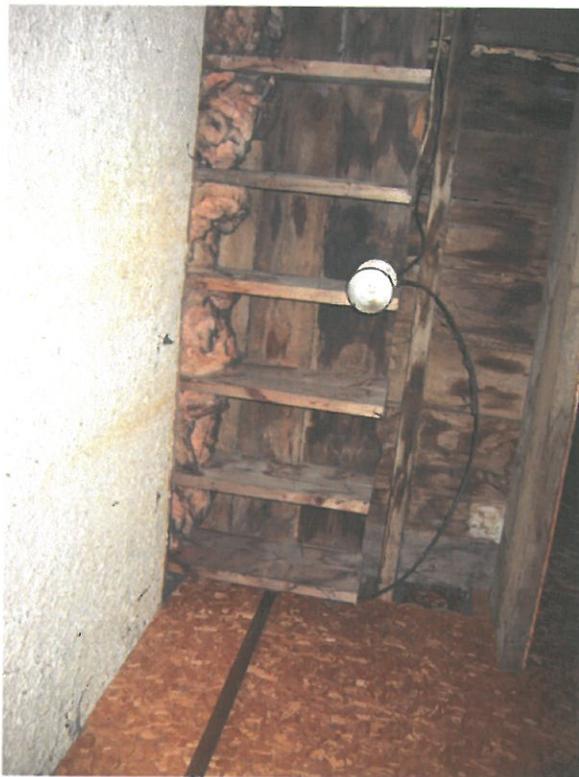
13. On the hose tower side of the opening, the framing for the second floor is exposed. It appears that the framing consisted of 2x12 floor joists at 12 inches on center with a sub floor of 8 inch wide boards. This can be seen in photo 27.

Photo 27 – Wood framing for second floor inside hose tower. Note the floor framing is 2x12's at 12 inches on center.

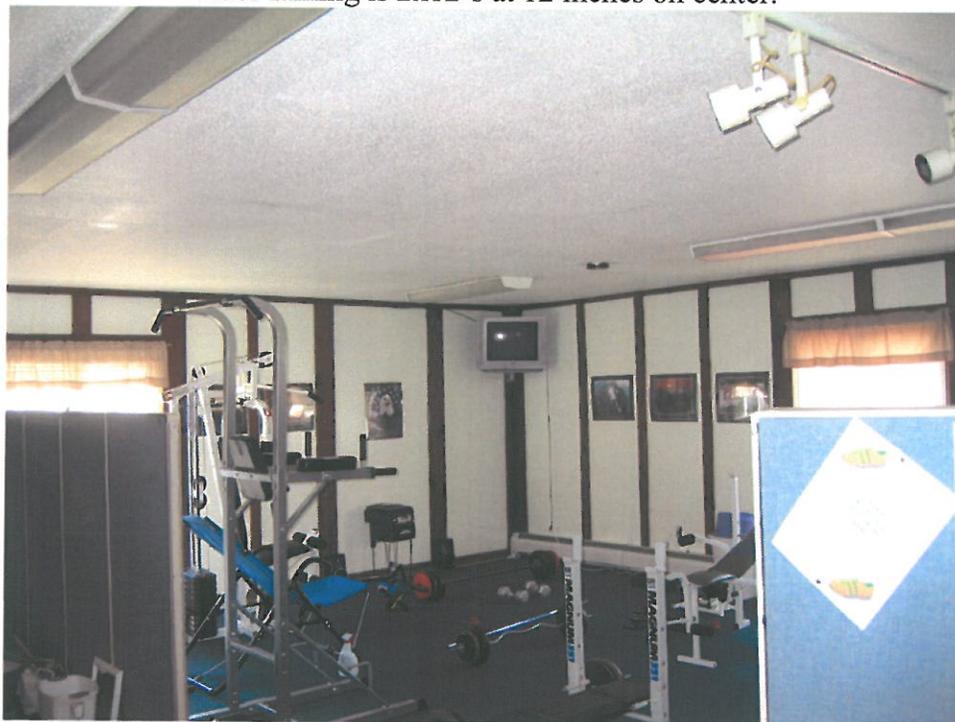
Photo 28 – Second floor south corner. Note there are no visible cracks in the ceiling or walls in the area above the crack at the first floor.

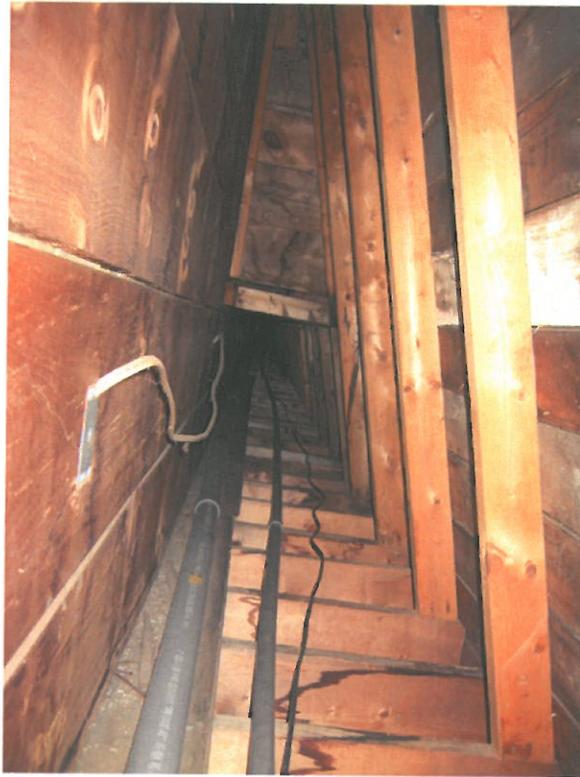
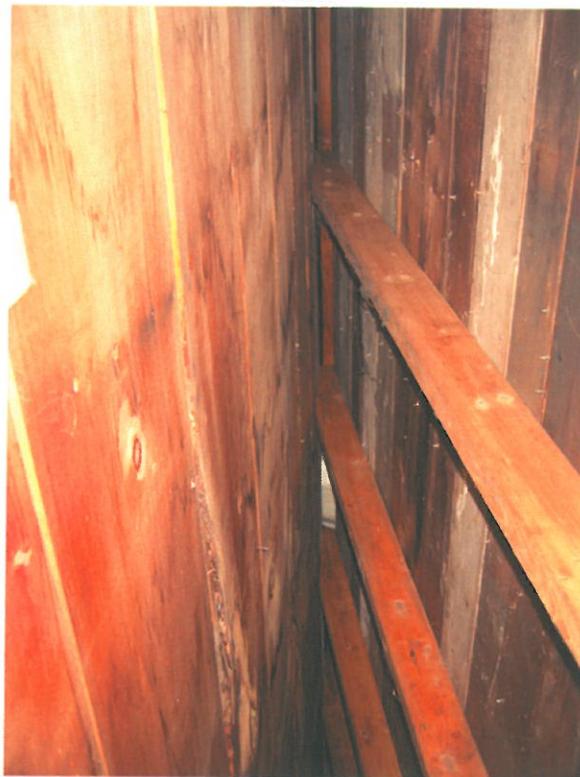
14. On the second floor there was no observed or reported cracks. Photo 28 shows the south corner which is above the step crack shown in photo 13.
15. The framing of the mansard roof can be seen in photos 29 and 30. These photos were taken through an access panel in the east corner of the second floor. In these photos it can be seen that the roof is framed with 2x4's and board. There is also some water staining on the ends of the floor joist indicating that the mansard has leaked in the past.

Photo 29 – Looking northwest along northeast side from east corner. Note the mansard framing and the floor joist cantilevered out over the first floor wall.

Photo 30 – Same location as photo 29 looking up at connection between mansard and roof.
